Intel[®] Celeron[®] Processor

Specification Update

August 2008

Revision 053

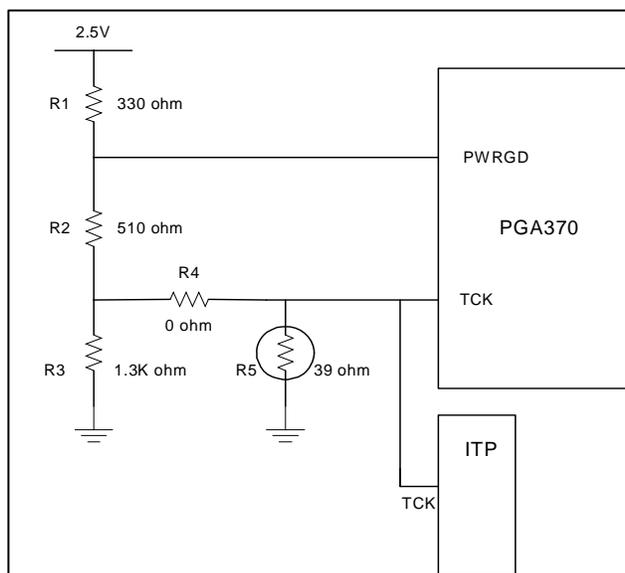
Figure 1 Celeron® on 0.13 Micron Processor 256K Platforms Workaround

In addition, the example workaround circuits shown do not support production motherboard test methodologies that require the use of the processor JTAG/TAP port. Alternative workaround solutions must be found if such test capability is required.

For Production Boards:

Depopulate R5
